Elevating and Amusement Devices Safety Program	Ref. No.: 303 / 23
ADVISORY	Date: April 30, 2023

Subject: Bearings on all 2 to 1 Roped Counterweights

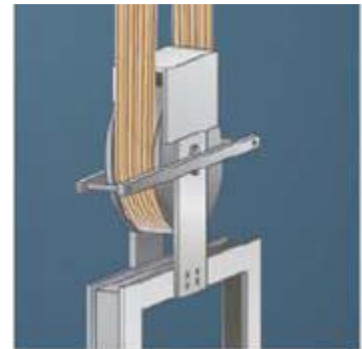
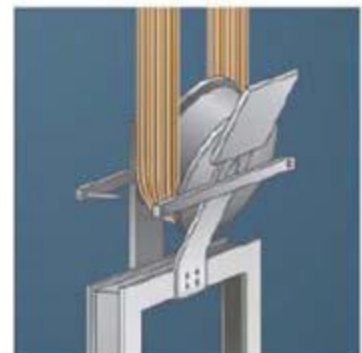
A recent **BEARING** failure on a roped counterweight, resulted in counterweight sheave being forcefully separating from the counterweight frame. Reference Directors Order 302/23.

The bearing failure caused the counterweight sheave to seize. This ultimately led to the hoisting ropes coming off the sheave and separating the sheave from the counterweight frame. In turn this caused the counterweight to freefall and the car to overspeed downwards onto the car safeties.

Bearings on 2 to1 roped counterweights should be included in routine maintenance checks to ensure they are operating smoothly and not presenting signs of wear, noise, or other symptoms which could signal pending failure.

Where the failure mode and effect analysis of a bearing arrangement has a high severity rating, such bearings should be included in routine maintenance checks and added to Maintenance control program documentation and the associated record of maintenance checks.
