Author <i>Auteur</i>	Release date <i>Date émission</i>	Doc. no. <i>No. de doc.</i>	 
SLC/GSM	12-31-2006	SA-06-022

SAFETY ALERT BULLETIN / BULLETIN DE SÉCURITÉ

Title / Titre : Tower failure due to water intrusion

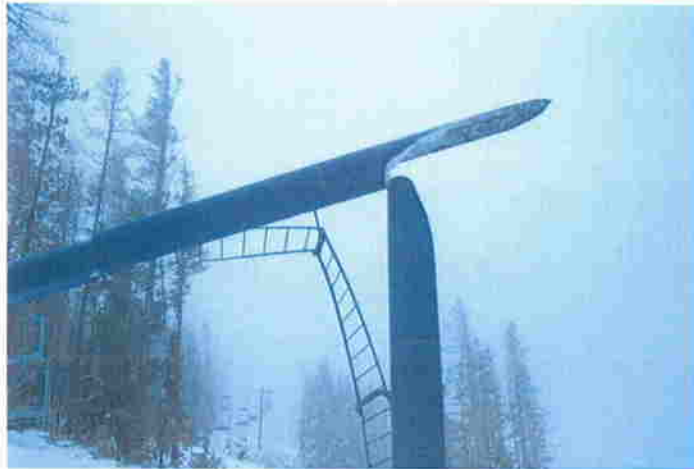
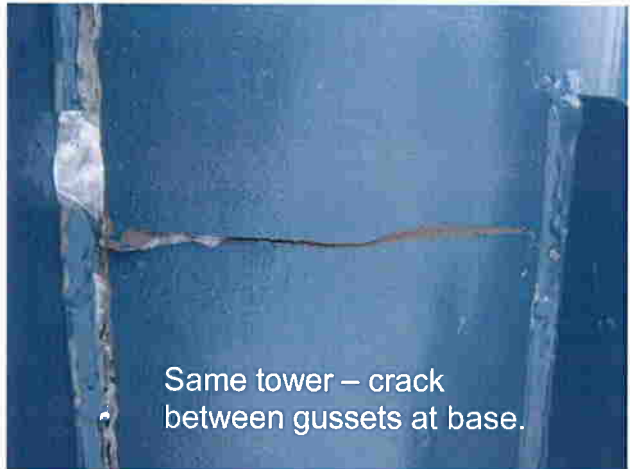
Tower: 6S/4S; 46' tall; 30' of 20" tube spliced to 16' of 16" tube. Ice filled to 30' position.

Weather conditions at failure:
Night; ~-5° F.; Wind ~ 57 mph.

Tower split vertically from base then hinged at approx. 18-1/2' and fell toward heavy side (uphill) line in the direction of prevailing wind.

Haul rope was trapped on both HS & LS assemblies.

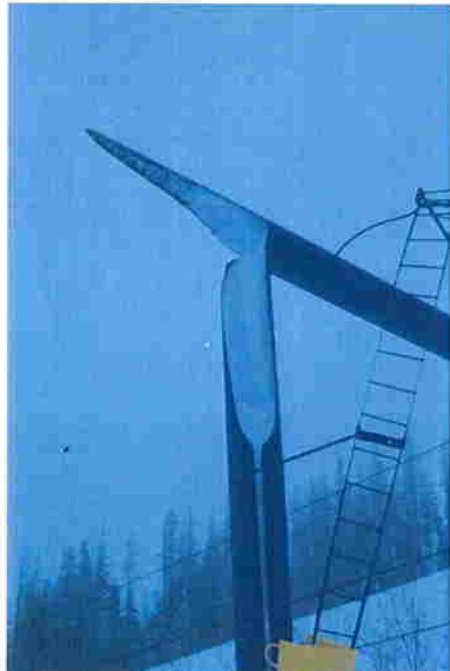
Horizontal tower base crack 10-1/2" long, 14" up from base.
