PARTEK SKI LIFTS
482 Newport Bridge Road
Pine Island, NY 10969
845-258-4552 845-258-4537 (fax)
800-626-4165 (toll free)
E-mail: partek@aol.com

SERVICE BULLETIN NUMBER 02-030510

SUBJECT: CRACKS IN ROPE GRIP BODY JAW

REFERENCES: DRAWING C-2715

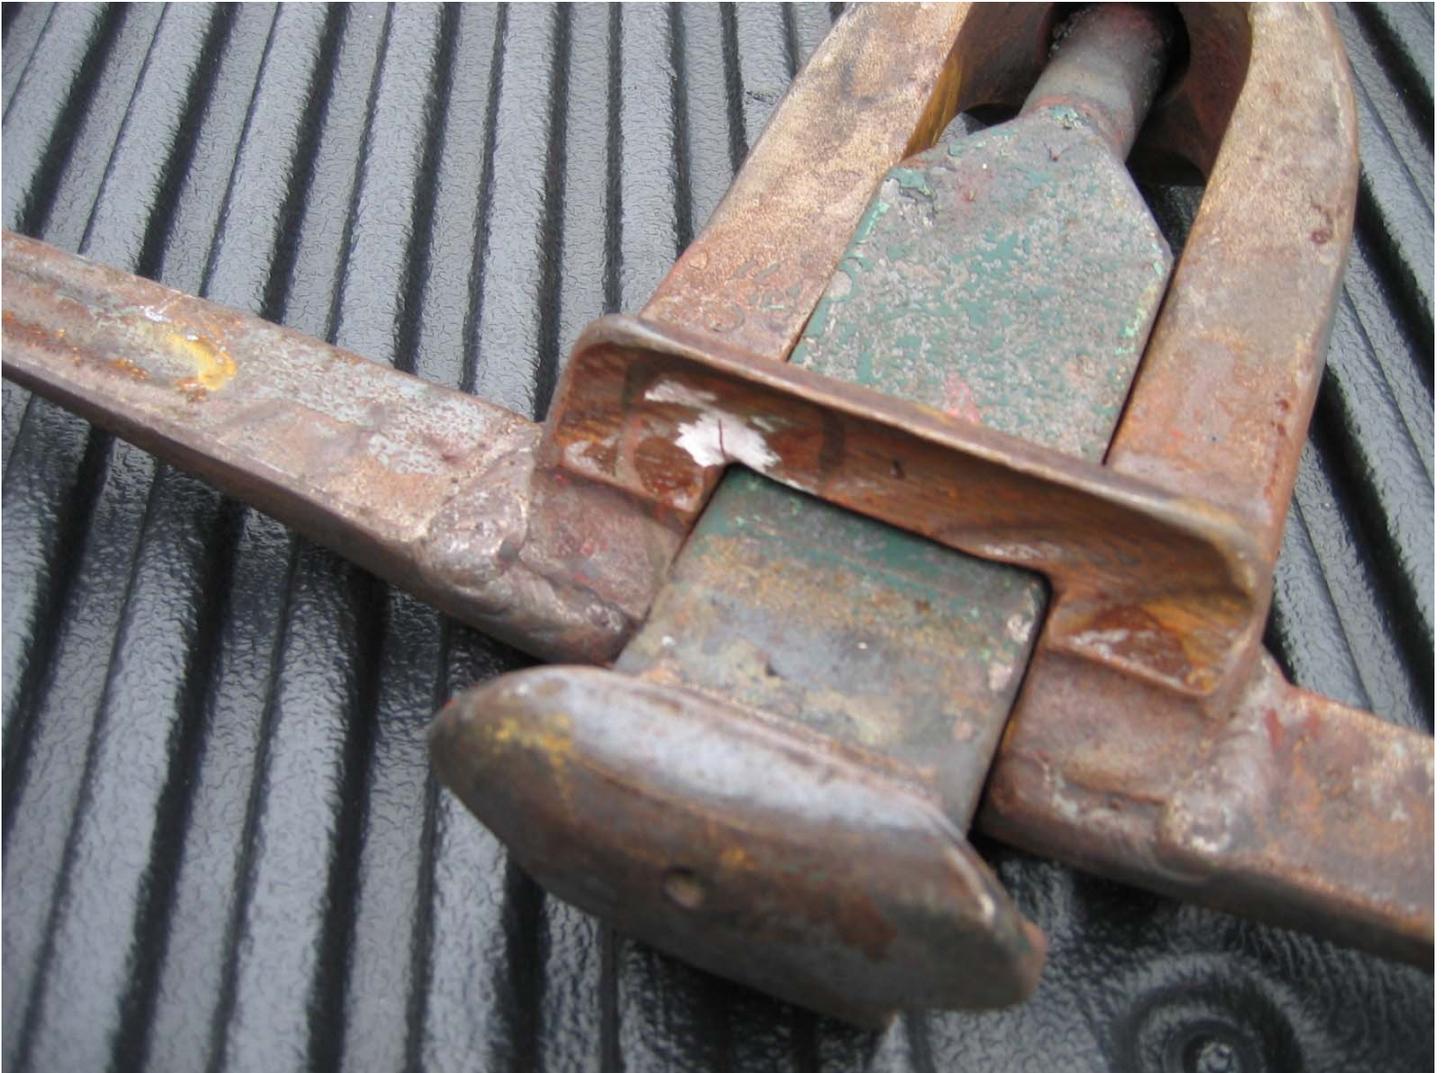
Critical indications have been discovered in the jaw area on the main grip body of the above mentioned grips that will require this model of grip to be removed from service in stages. The bulk of these grips were supplied on Borvig lifts from 1976-1980. Some lifts built in 1975 and in 1981-2 may not be affected since they were supplied with a different model of grip. If your lift does not have this particular style of grip, this bulletin does not affect your lift.

The cause of the failures is due to several factors, in many cases a combination thereof. Metal fatigue is the primary cause. In some cases, severe coining of the grip jaw, poor maintenance of bullwheel liners, gaps in bullwheel liners and the use of hard urethane sheave liners have contributed to the failure. These grips have been in service for over 30 years and have endured many millions of cycles passing over sheave assemblies and around bull wheels.

Photo Of Crack

The affected grips are to be replaced as follows:

1/3 Prior to 11/15/10
1/3 Prior to 11/15/11
1/3 Prior to 11/15/12

All existing grips will have to be 100% NDT tested in order to establish how many grips have indications. If more than one third are found to have indications, those additional grips will also have to be replaced prior to 11/15/10.

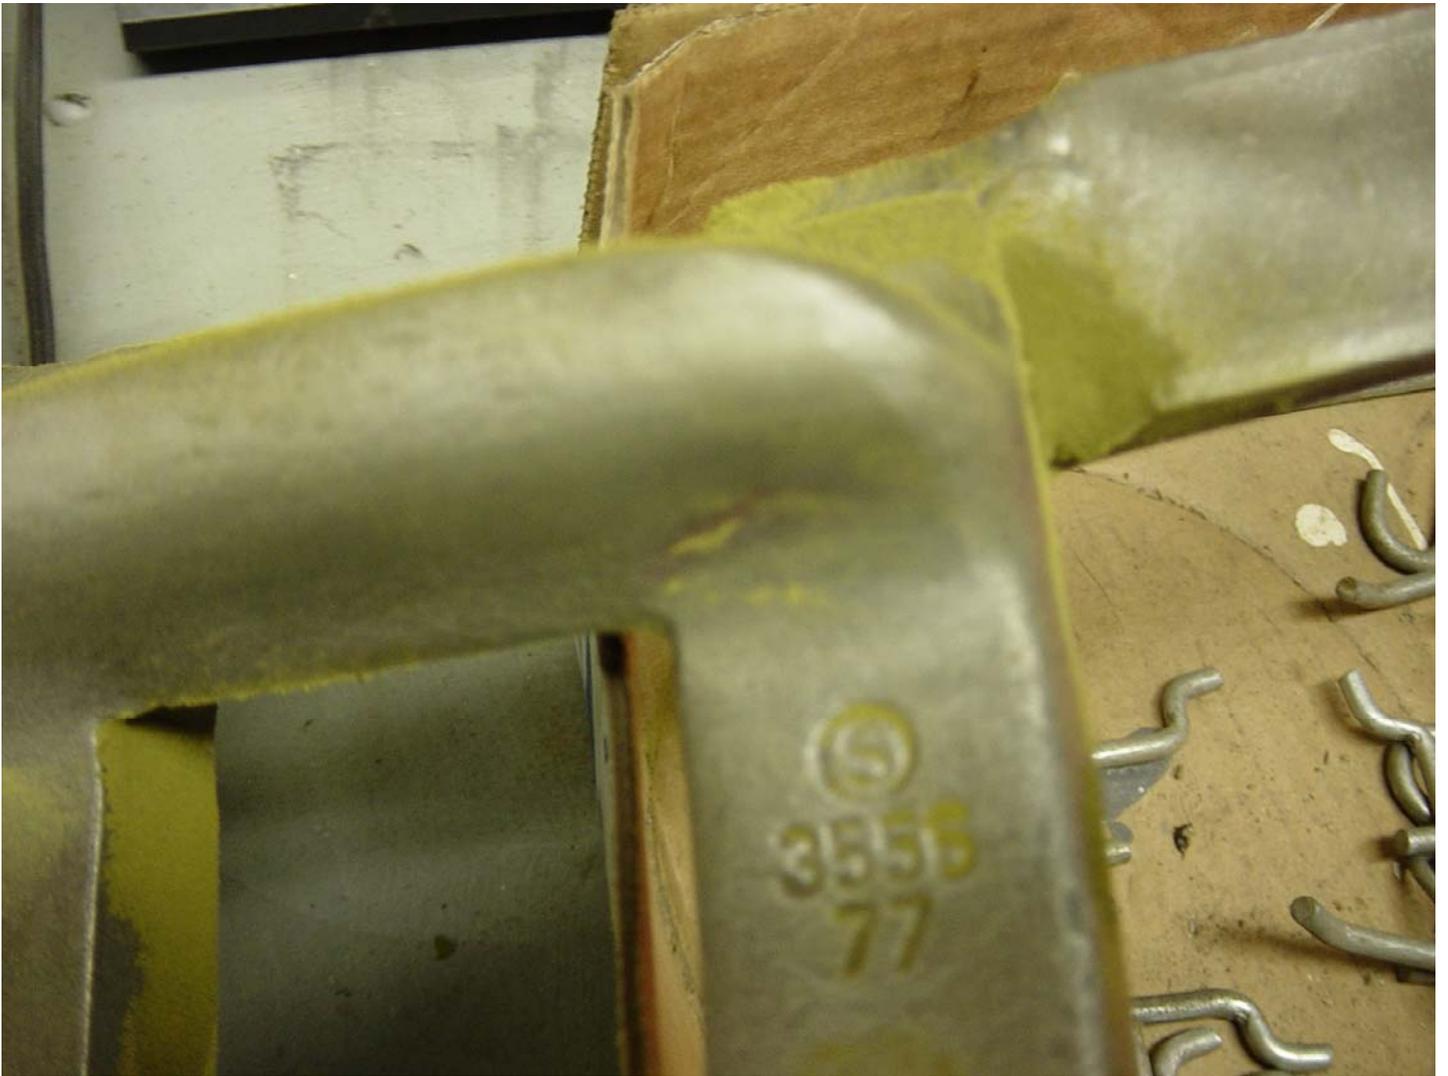
Grip Year Identification

According to our records, there are 2,888 of these grips that were supplied by Borvig. Some have already been replaced. These grips can easily be identified, the main journal where the chair head attaches to the grip is 65mm in diameter with two snap ring grooves, 24 spring washers and the grip body has welded metal grip guides. Later models had pivoting metal grip guides and even later models used plastic grip guides, they are not affected by this bulletin. The year of manufacture is cast in the grip as "75", "76", "77", "78", "79", and "80". Most were delivered in 1977, 1978 and 1979.
