DIRECTOR'S SAFETY ORDER

### Re: Dover Counterweight Frame Cracks and Repair

## **TKE Technical Bulletin**

Dover-Turnbull Canada Counterweight Frames

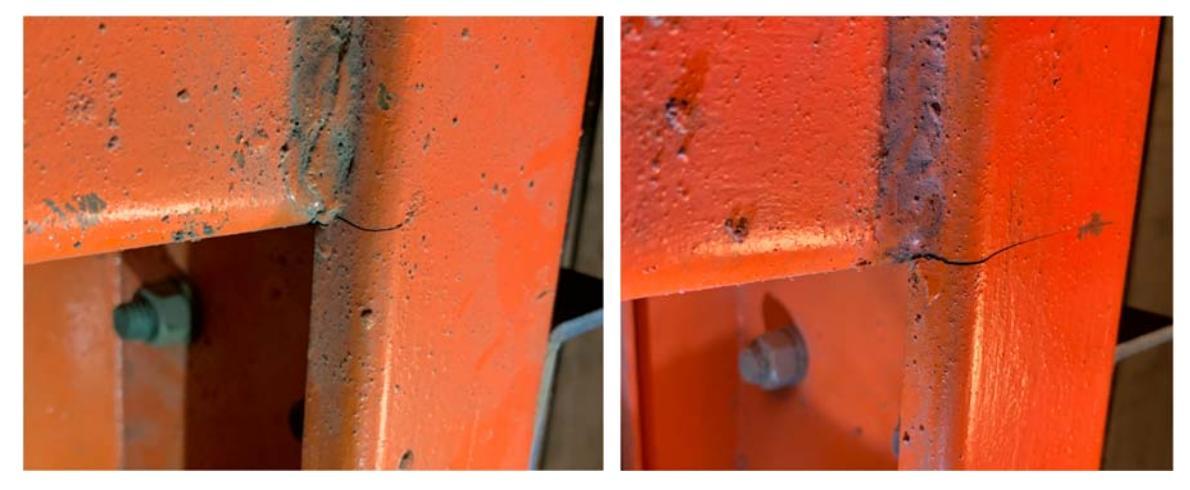
We recently found that some Dover-Turnbull Canada counterweight frames have developed cracks on the uprights (stiles) near the top weld with the crosshead. This is due high stresses developed in the cracked region because of asymmetrical welds between the crosshead and the upright.

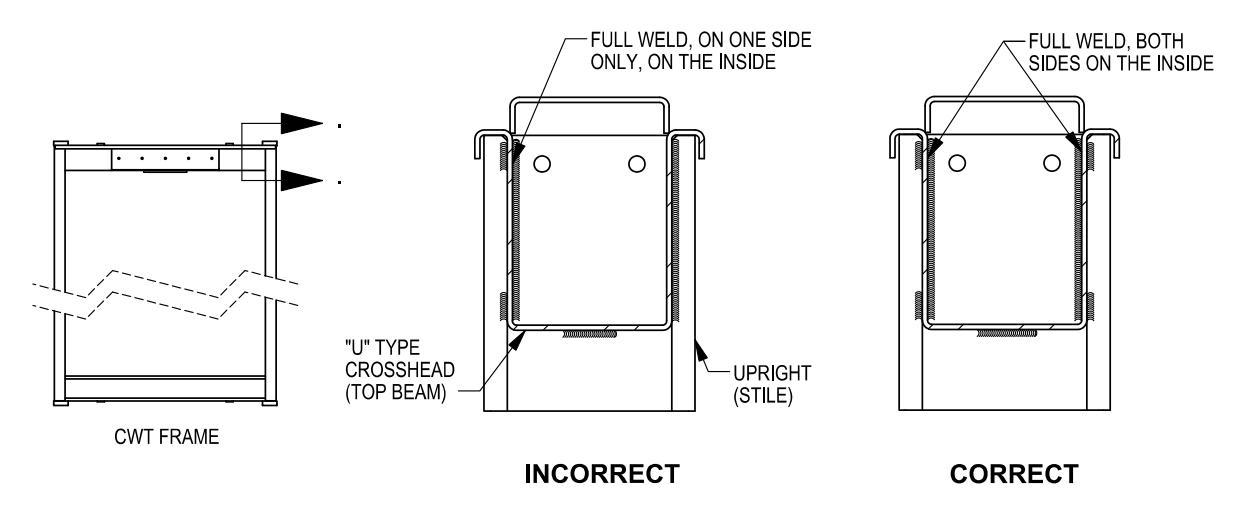
When welded properly, the crosshead is welded to the upright by a full weld on each side on the inside of the crosshead web, and two intermittent (1in long) on the outside. The improperly welded crosshead will have only one side the crosshead web welded on the inside.

If the crosshead is welded incorrectly, it needs to be reinforced to prevent high stresses.
