CUNICAL STANDTAND	Fuels Safety Program	Ref. No.: FS – 089 - 06	Rev. No.:
PUTAETY AUTHORIT	ADVISORY	Date: July 2006	Date:

Subject:	Tobacco Kilns
Sent to:	Posted on the TSSA Web-Site, Ontario Flue-Cured Tobacco Grower's Marketing
	Board, Heat Exchanger Manufacturer's

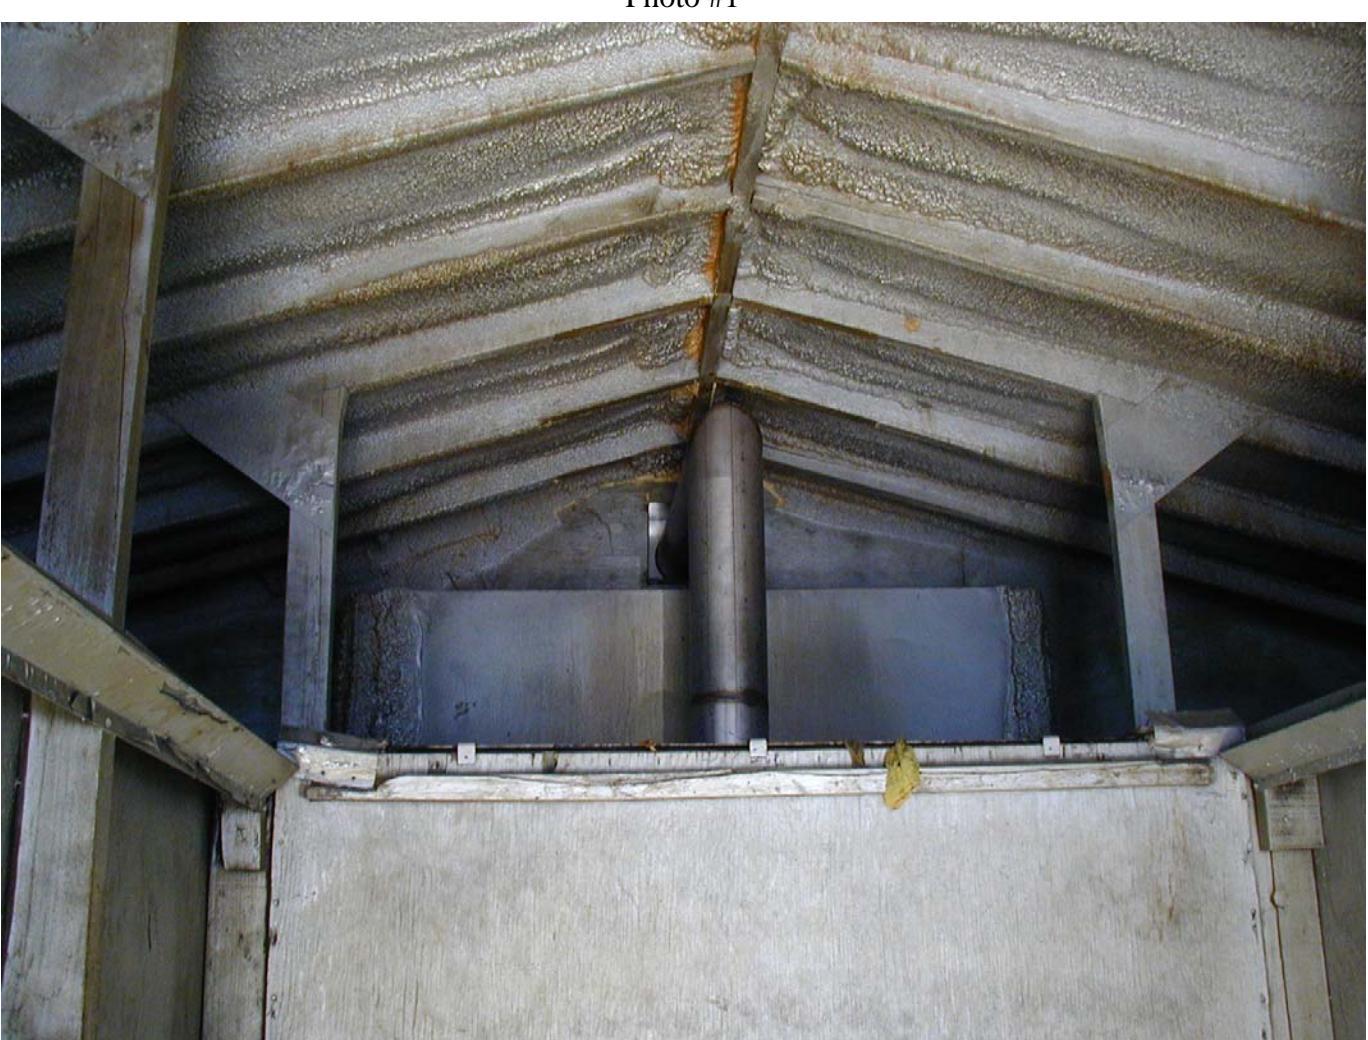
Photo #1

During a power outage or air circulation failure inside the Bulk kiln, dangerously hot temperatures may occur above the return air opening of the heat exchanger assembly, see photo #1. This is the result of heat being emitted from the heat exchanger by natural convection. This is especially prevalent when the kiln is operating in the high heat mode. The temperature inside the kiln during this mode is often between 150 to 160°F. Under this situation, limited field testing has shown that temperatures may increase up to 50°F above acceptable limits for combustible materials.

The TSSA strongly urges kiln owners to take appropriate steps in order to mitigate this potential hazard. These steps may include installing thermal insulation or heat shields that provide temperature protection. To protect against a power outage, use a standby generator as back-up power. To ensure the best hazard prevention solution for your kilns, consult with the heat exchanger manufacturer or a Professional Engineer knowledgeable in this area.
