Mandatory Product Update/Safety Bulletin

PCWU 15-012 Rev B (Replaces PCWU 15-012)
 PC3/Titan Overspeed Safety Device - Safety Bulletin
 October 20, 2015

SUB COMPONENT
Overspeed Safety Device - Flywheel Assembly

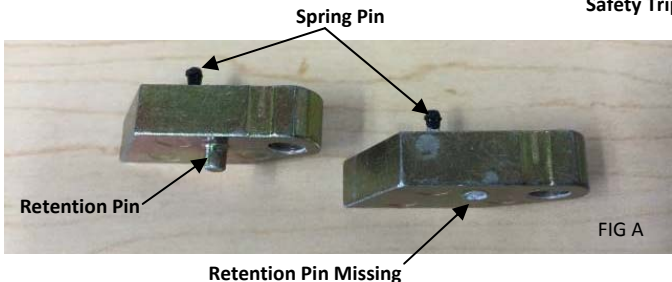
Pictures provided from one unit indicate that the flywheel counterweight pins had fallen out or sheared off (see Fig A). If a pin falls out or shears off, the counterweight may get caught on surrounding structure, see Fig B (ex: test push button or mounting bolts). This results in a condition where the flywheel will not trip the overspeed safety trip trigger. In the unlikely event of a loss of traction of the suspension rope in the traction sheave, or a drive train failure leading to a freewheeling traction sheave, the Overspeed Safety Device Cam will not engage and stop motion of the Service Lift.

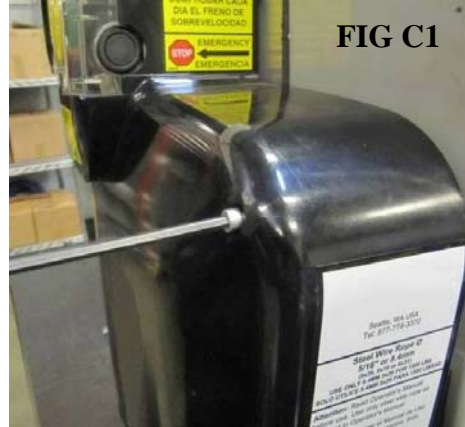
FIG C1

1. Prior to performing Daily Inspection Procedure checks, with Service Lift power off, remove Hoist Mainframe Cover (Fig C1) using a 4mm T-Handle. Locate the Flywheel Assembly (See Fig C2). **Manually rotate each flywheel counterweight (4 Total) on Flywheel Assembly** of the Overspeed Safety Device to ensure that their rotation past the outer diameter of the flywheel is limited as shown in Fig D1 & D2 below. If it can move too far and get caught on obstacles other than the trigger for the stop as shown in Fig E, the Flywheel does not pass inspection.

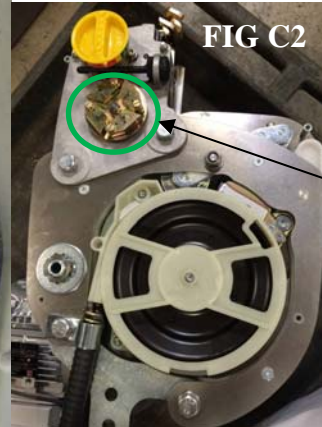
FIG C2

Flywheel Assembly
