LEITNER-POMA SERVICE NOTICE

NOTICE NO: SN-0701-01-R0

AFFECTED COMPONENTS: BM Manufactured Chairs

SUBJECT: Armrest Bracket Holes

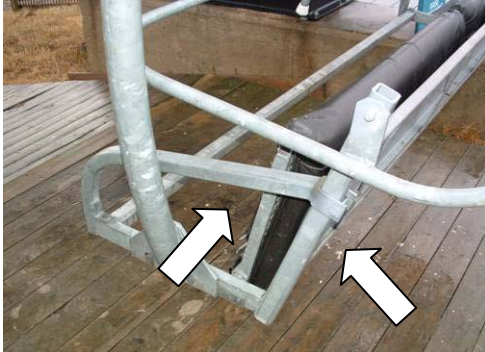
**ARMREST BRACKET
(ASSEMBLED)**

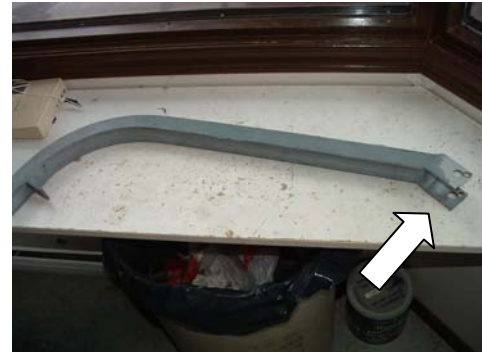
**ARMREST ATTACHMENT BRACKET
(DIS-ASSEMBLED)**

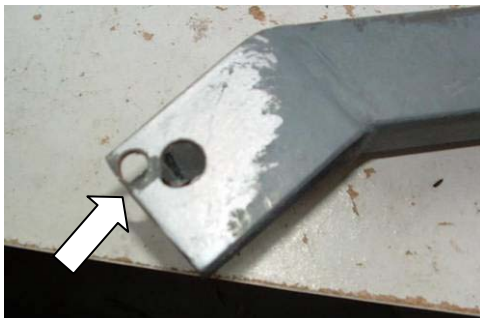
**EXAMPLE OF ADDITIONAL HOLE
TOO CLOSE TO EDGE (TOP VIEW)**

2. **REPORT ANY OCCURENCES:** If any extra holes are found, or if a holes edge is found to be closer than 2 X the material thickness from the material edge, please contact Leitner-Poma Canada by fax and provide a summary report indicating the installation number of the lift and the quantity of carriers that have been affected. A repair procedure is being developed and will be distributed accordingly.
3. **CONFIRM THE RECEIPT OF THIS NOTICE:** (mandatory) Please complete, sign, and fax back the following page as acknowledgement of receipt to:

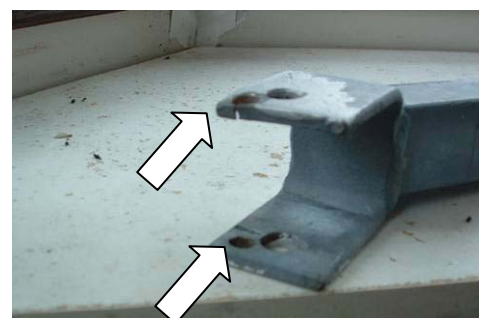
**EXAMPLE OF ADDITIONAL HOLE(S)
(ISO VIEW)**

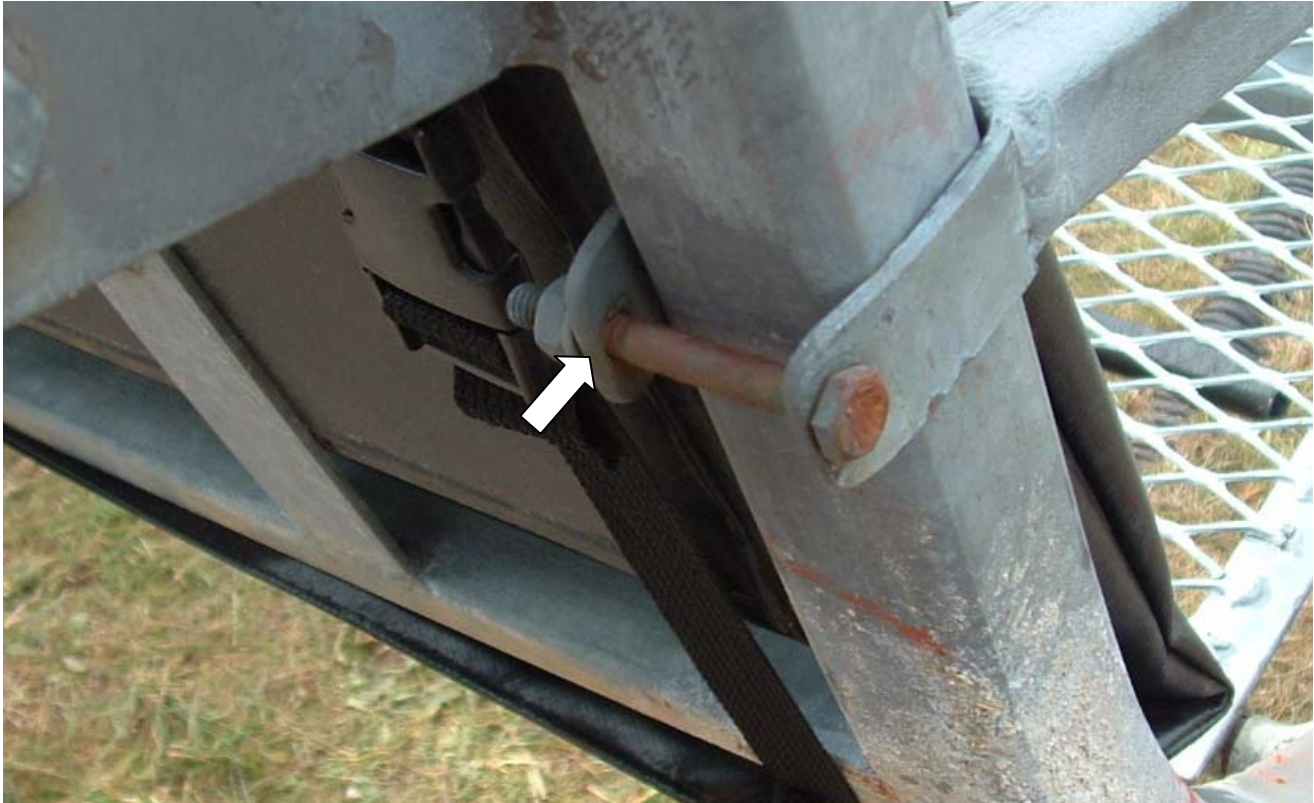
EXAMPLE OF HOLE TOO CLOSE TO EDGE
